Plates

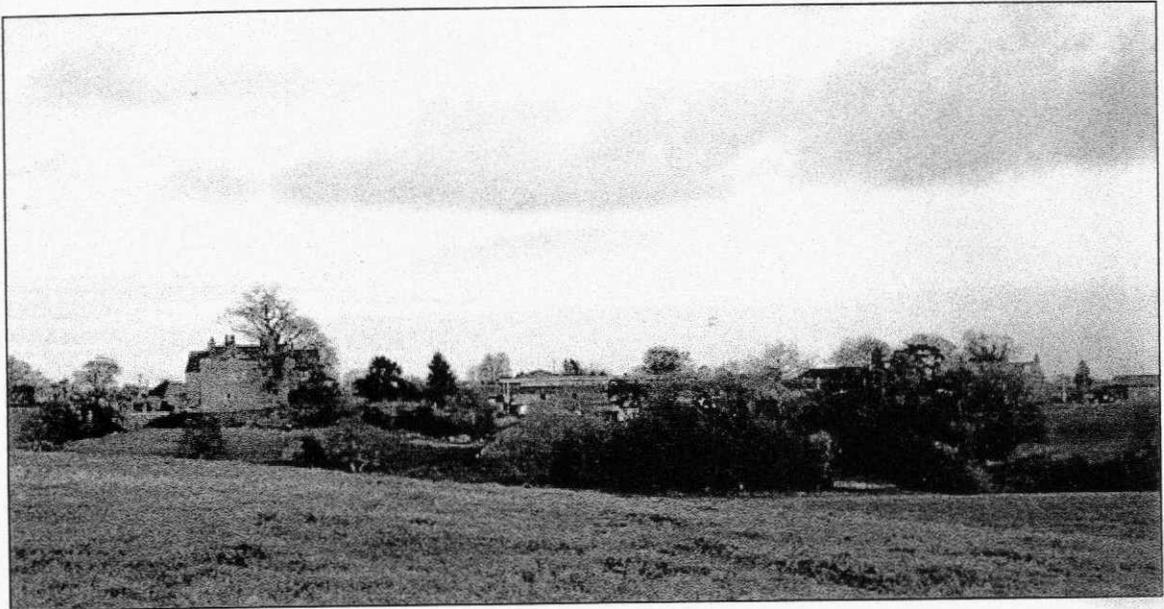
PLATE 1 (above): Setting: the hamlet of Stanwardine occupies a defensible location on a low plateau, and comprises the hall, on left, and its buildings with what was its home farm, Stanwardine Farm, on the right

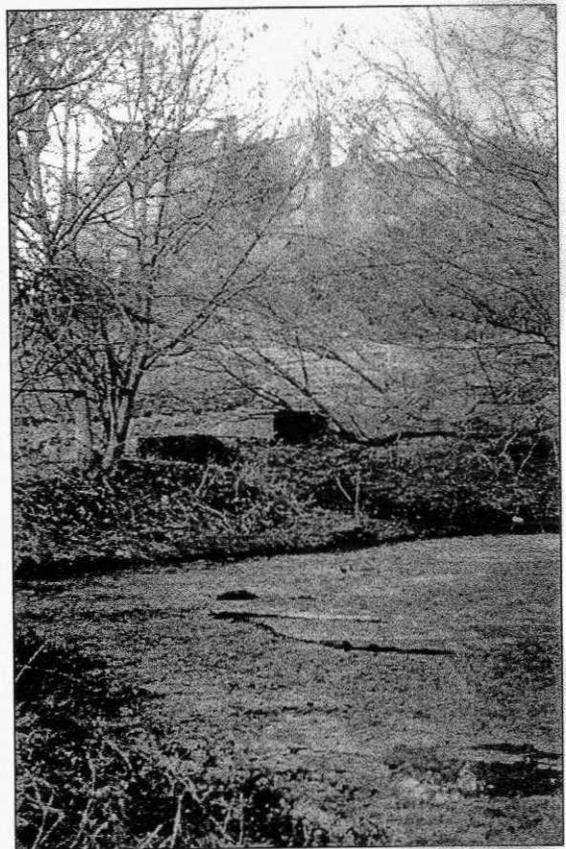
PLATE 2 (right): The moat which surrounds the site of the present hall's medieval predecessor, abandoned by the Corbets in the second half of the 16th century

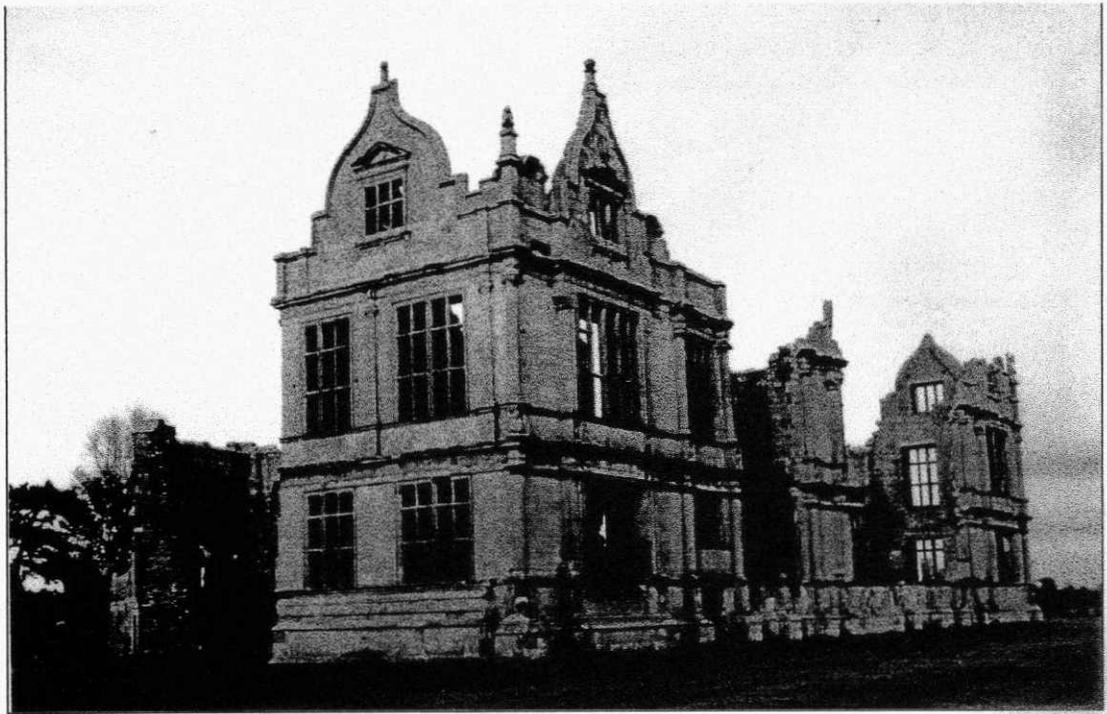
PLATE 4 (above): Morton Corbet Castle, built in 1579 by the main branch of the family, provided clear inspiration for Robert Corbett and his successors in their building of Stanwardine Hall

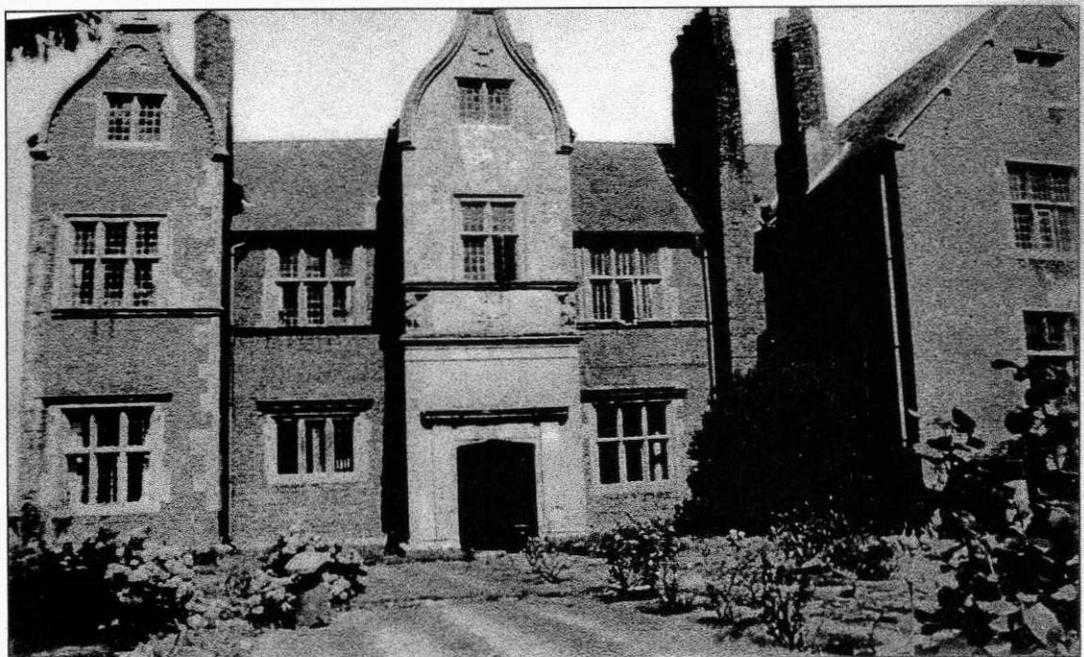
PLATE 6 (below): How the main façade of Stanwardine Hall shows the influence from Morton Corbet

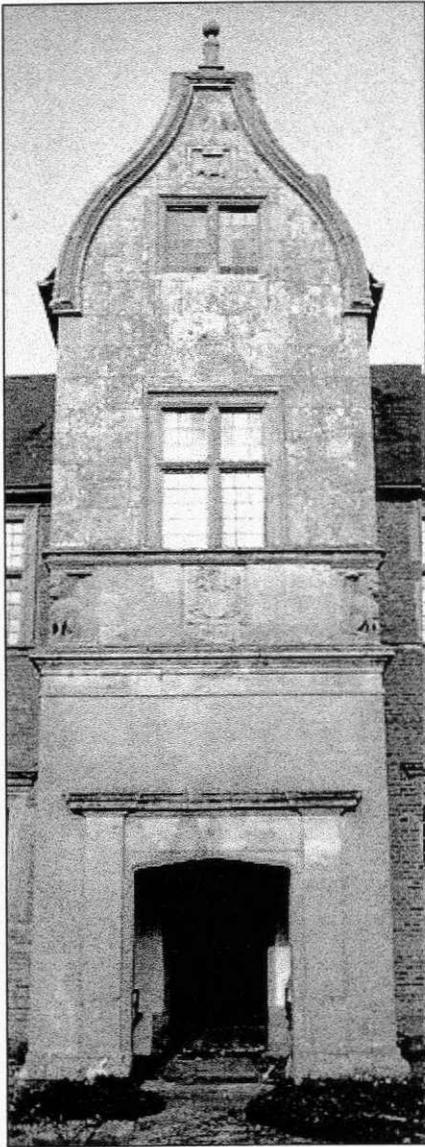
PLATE 7 (left): The tall porch, faced in Grinshill stone, with shaped gable

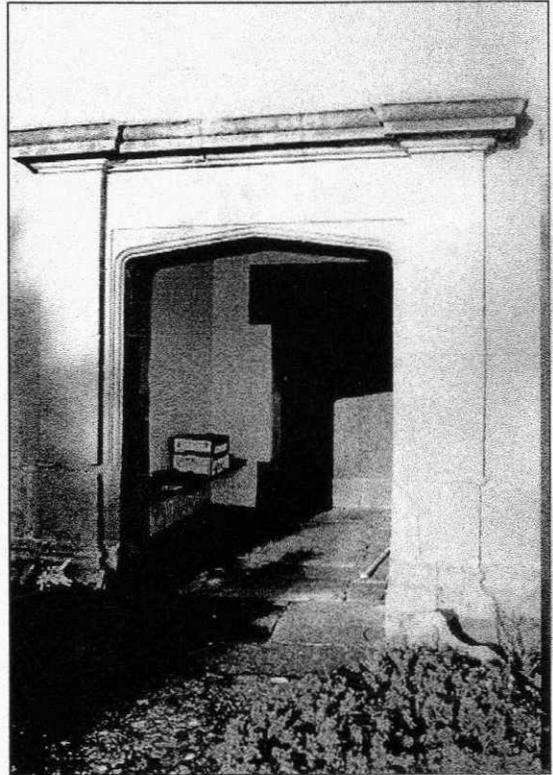
PLATE 9 (left): Graffiti on jamb of porch

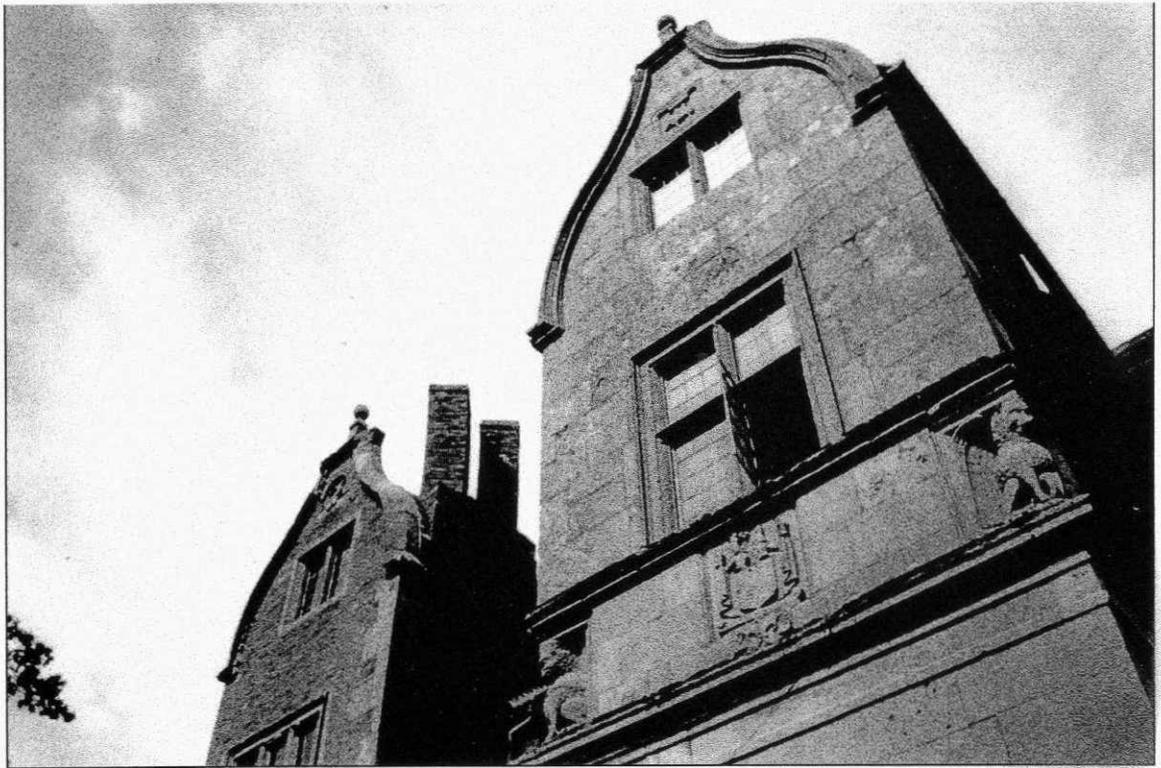
PLATE 11 (top): Contrasting gables of porch and west wing. PLATES 12, 13: griffins on porch. PLATE 14: Elephant plaque has names of Thomas and Margaret Corbet PLATE 15: Corbet arms on porch

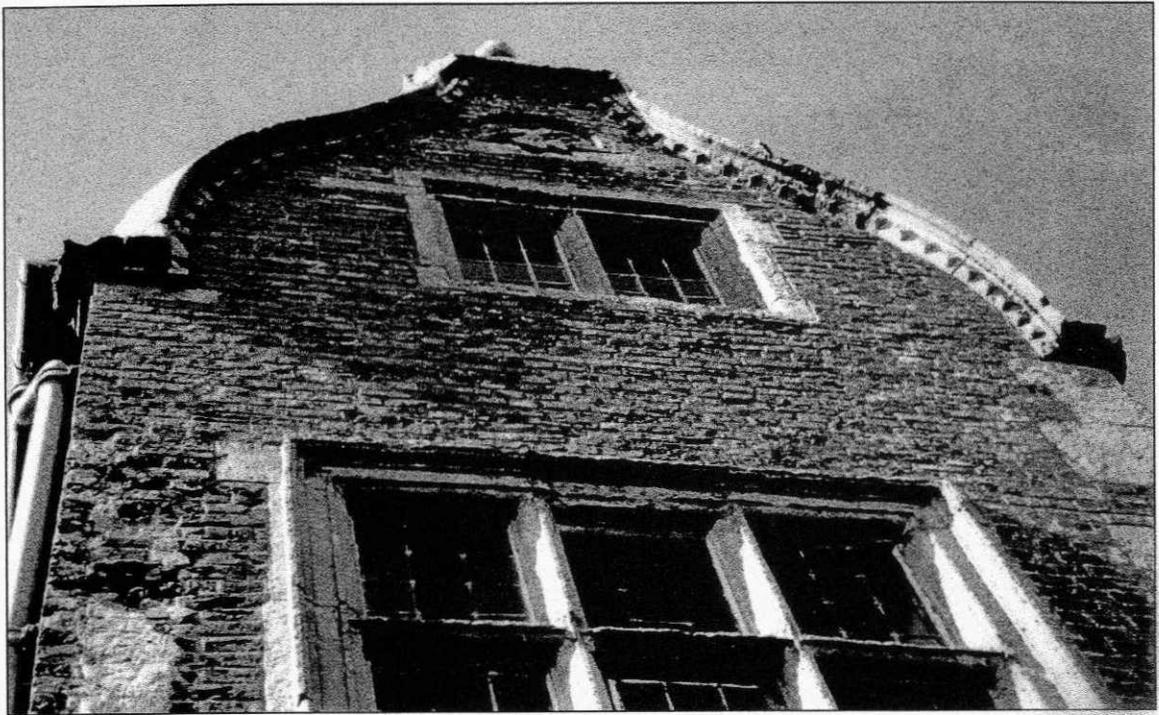
PLATE 16 (above): Attractive dentilation on gable of west wing. Contrast between brick and stone produced the 'red and white' effect popular in gentry mansions at that time

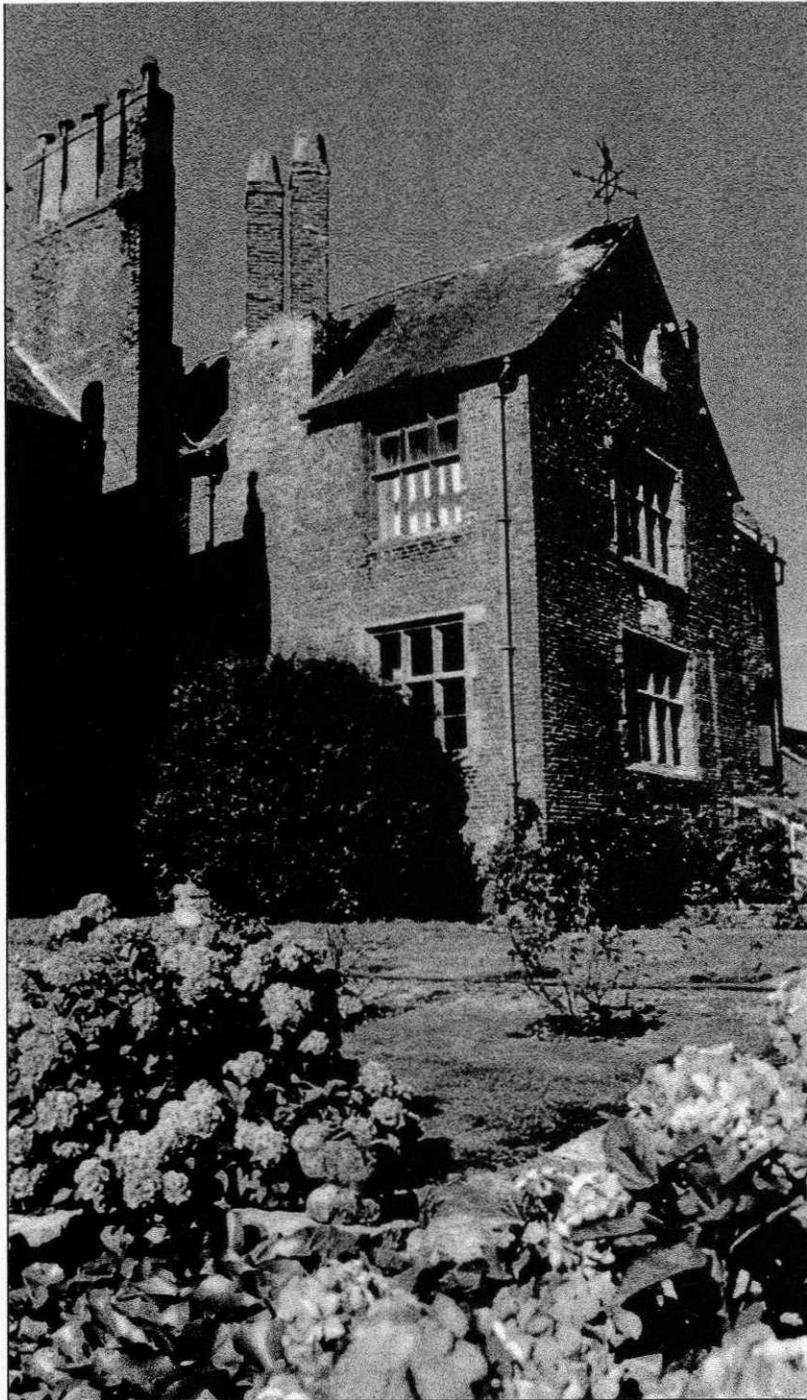
PLATE 23 (left): Massive service wing, from southwest, is earliest part of the hall, perhaps 1567-1588

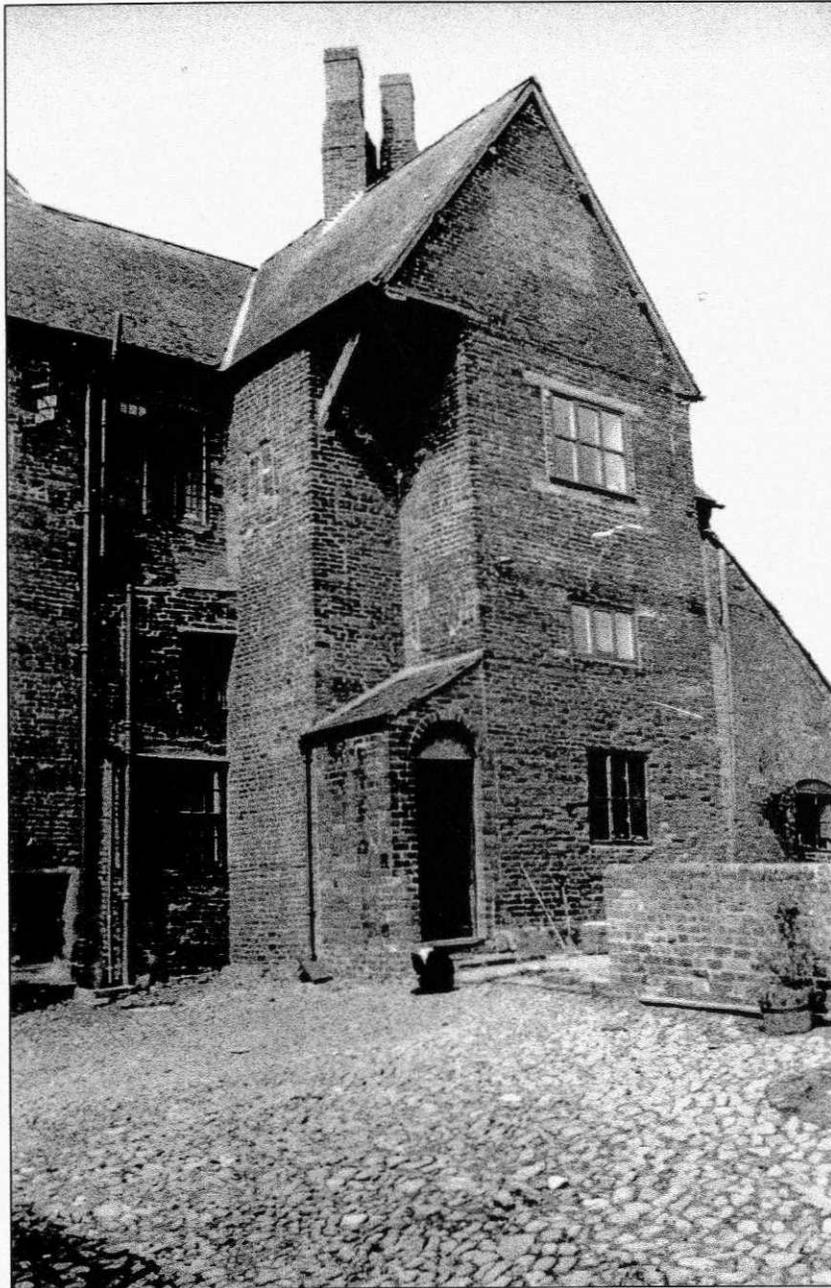
PLATE 28 (left): The bell tower was a later addition to the service wing, probably late 16th century, and perhaps originally a brewhouse

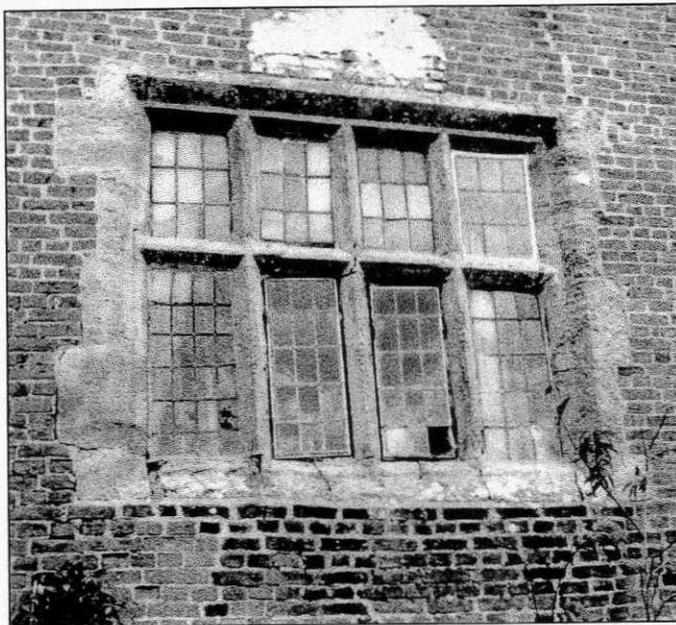
PLATE 33 (above, left): Four-light transomed window of first chamber on first floor of service wing. PLATE 34 (above, right): Tall, unusual cross window of early 1700s on rear wall of wing lights both kitchen and cheese room

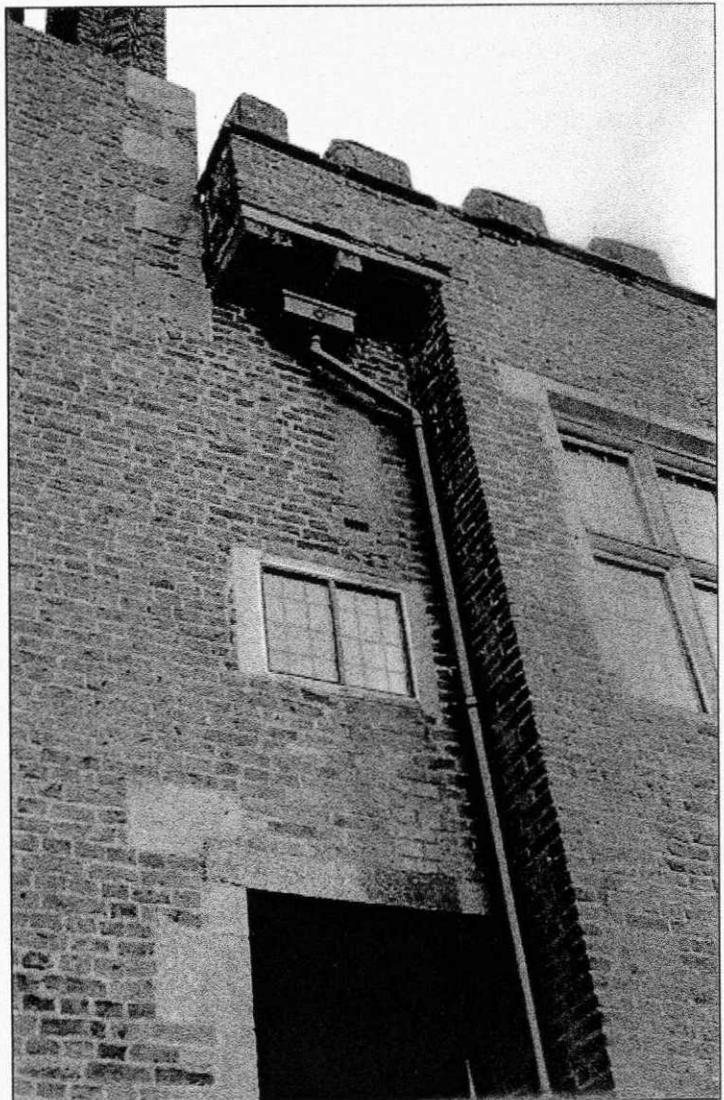
PLATE 42 (right): North tower, with jettied out portion of observation deck, is a later addition and included projection thought to have been a garderobe

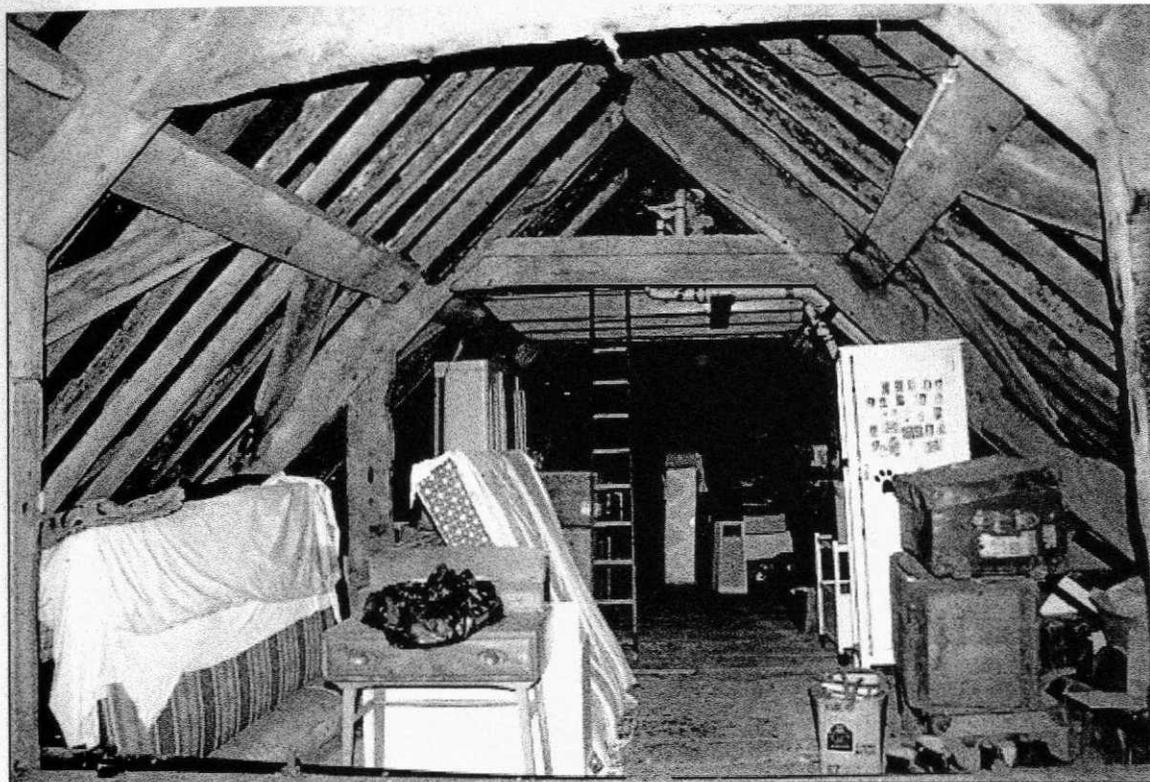
*PLATE 87 (above): Queen strut
roof trusses of hall range, from
west*

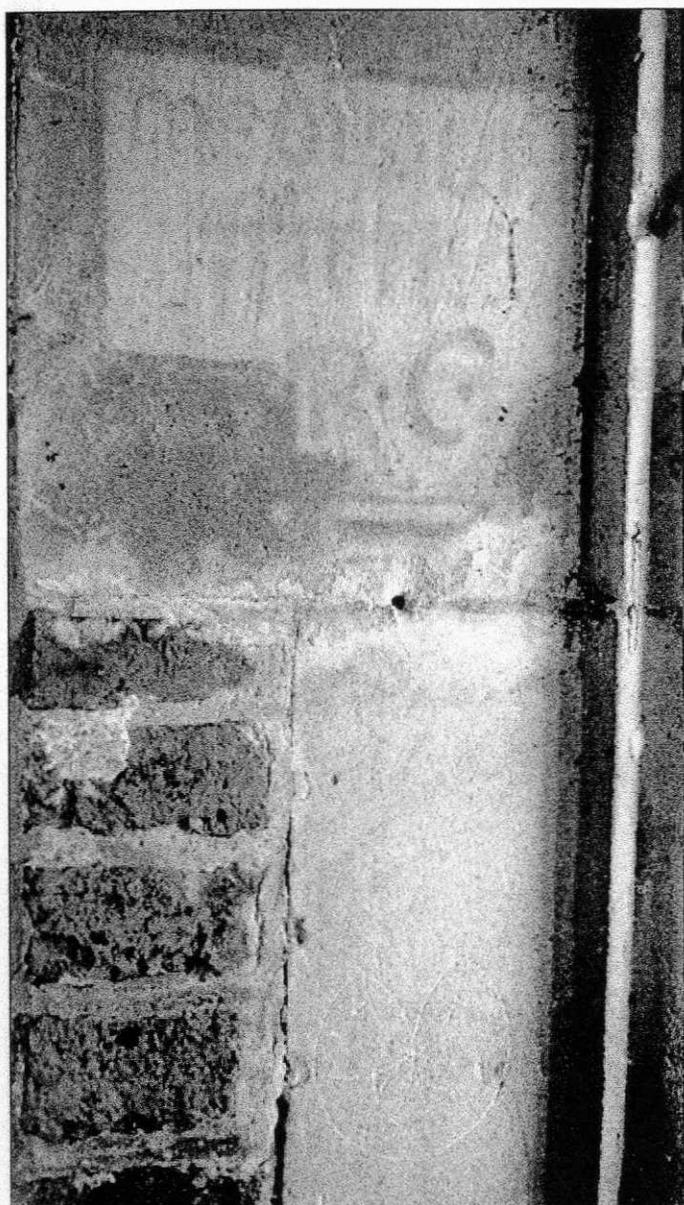
*PLATE 88 (left): Painted
decoration on jamb of porch attic
window, reading 'Mediocra
ffirma' – 'the middle ground is
safest' – with the initials RC,
probably Robert Corbett II*

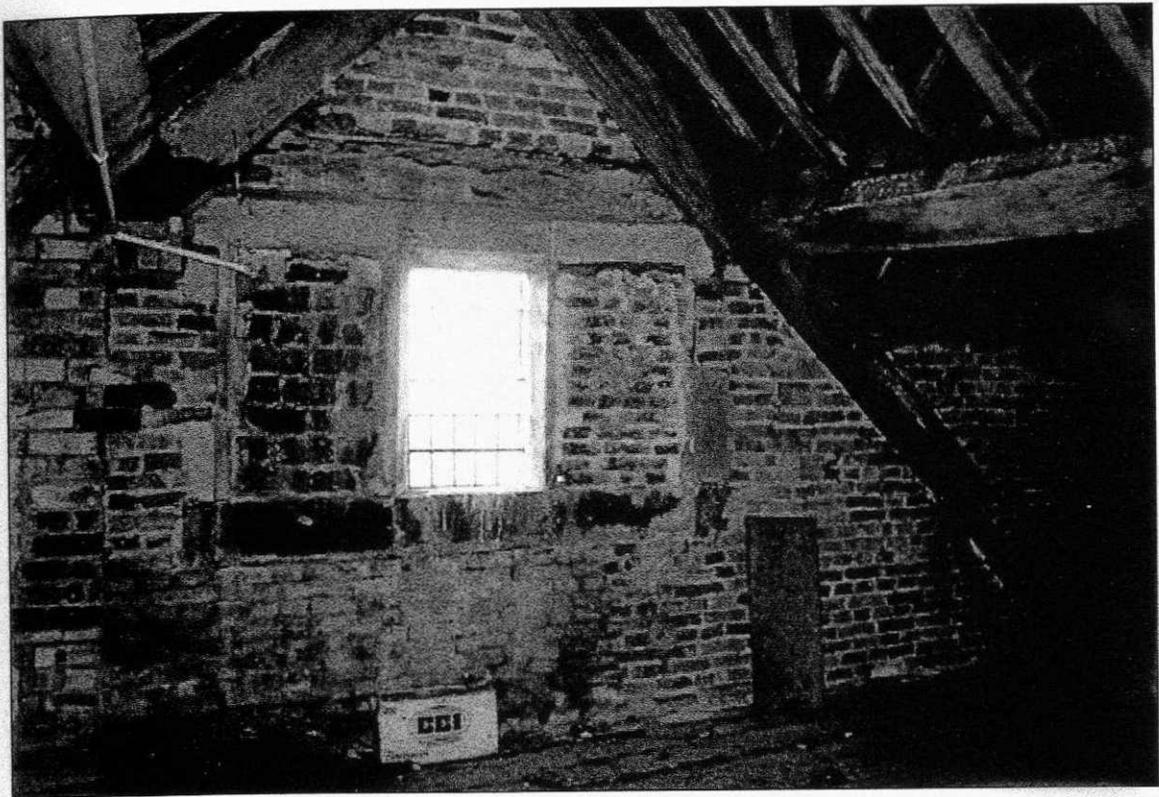
PLATE 89 (above): Western gable of attic showing remains of roof truss within later brickwork

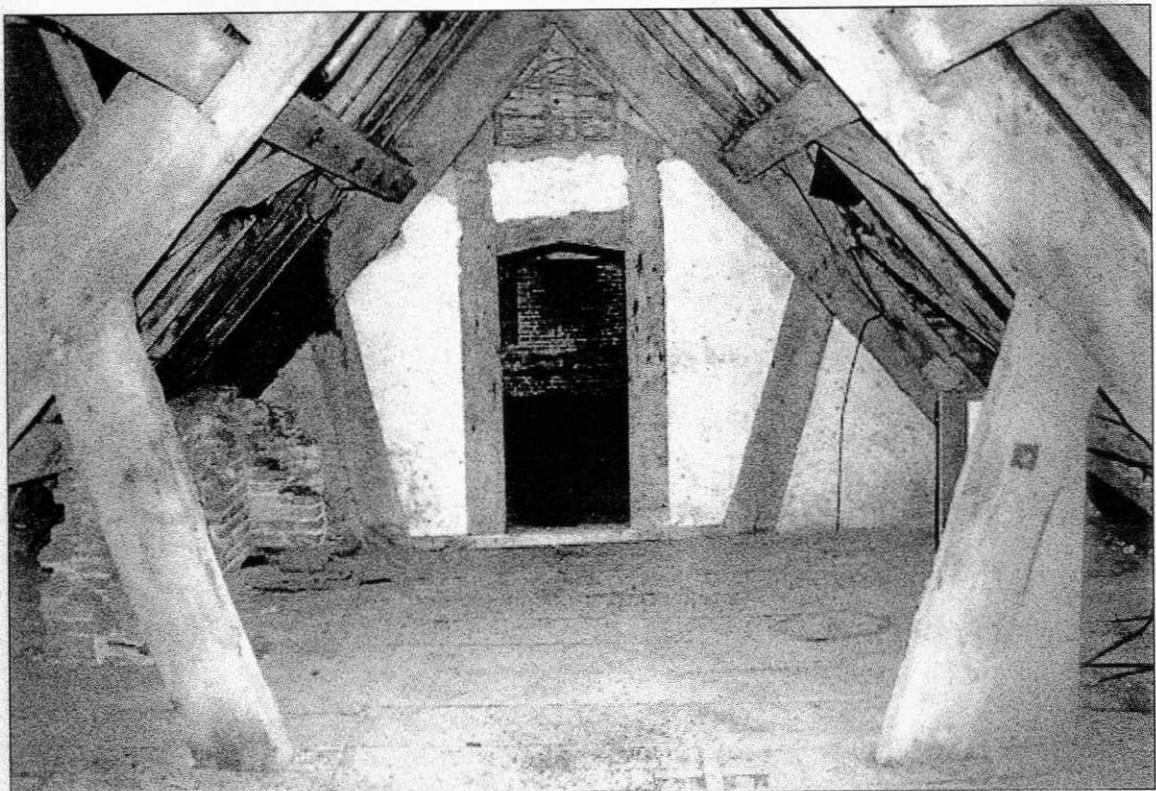
PLATE 90 (below): Heavy angle strut roof trusses in wing over attic, with triangular-headed doorway set in wattle and daub partition between 6th and 7th bays

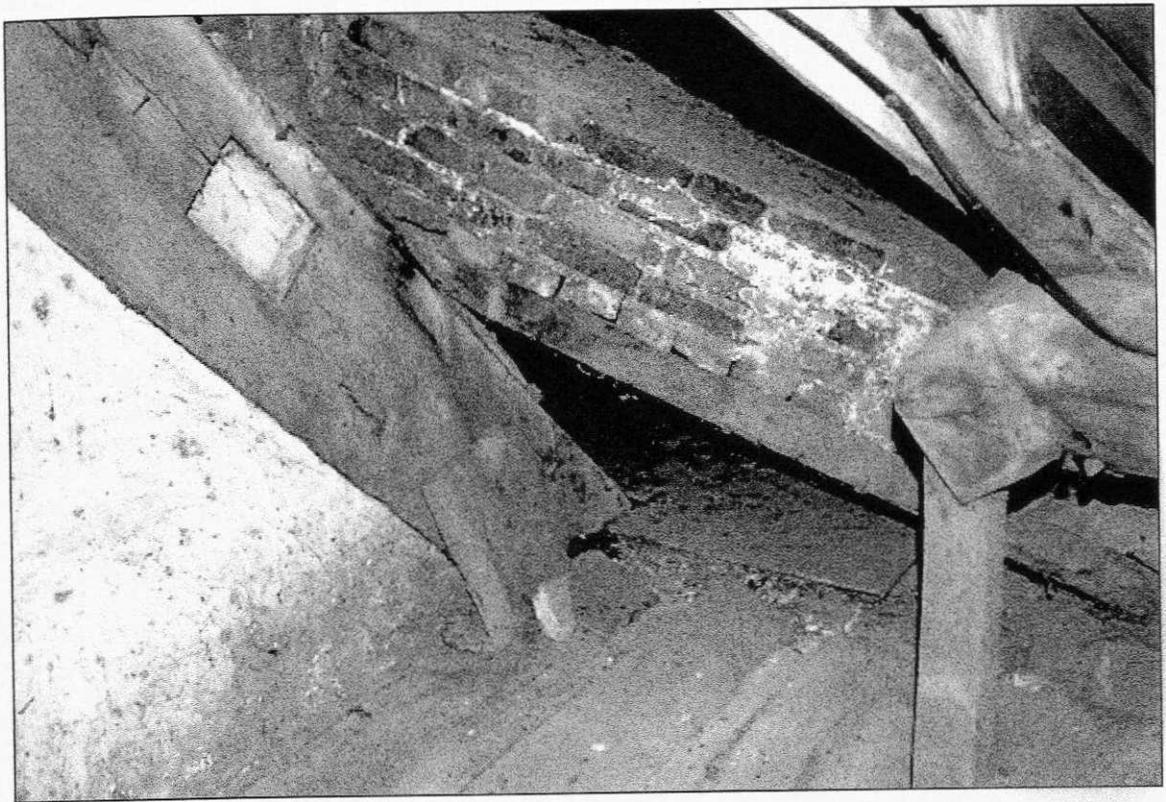
PLATE 91 (above): Stub remaining in principal rafter mortice indicates purlin was removed to allow access to bell tower - proving latter is an addition. Also, brick flue from fireplace in breakfast room and chamber above, unusually angled to join flue of kitchen hearth - shows this too was probably added later

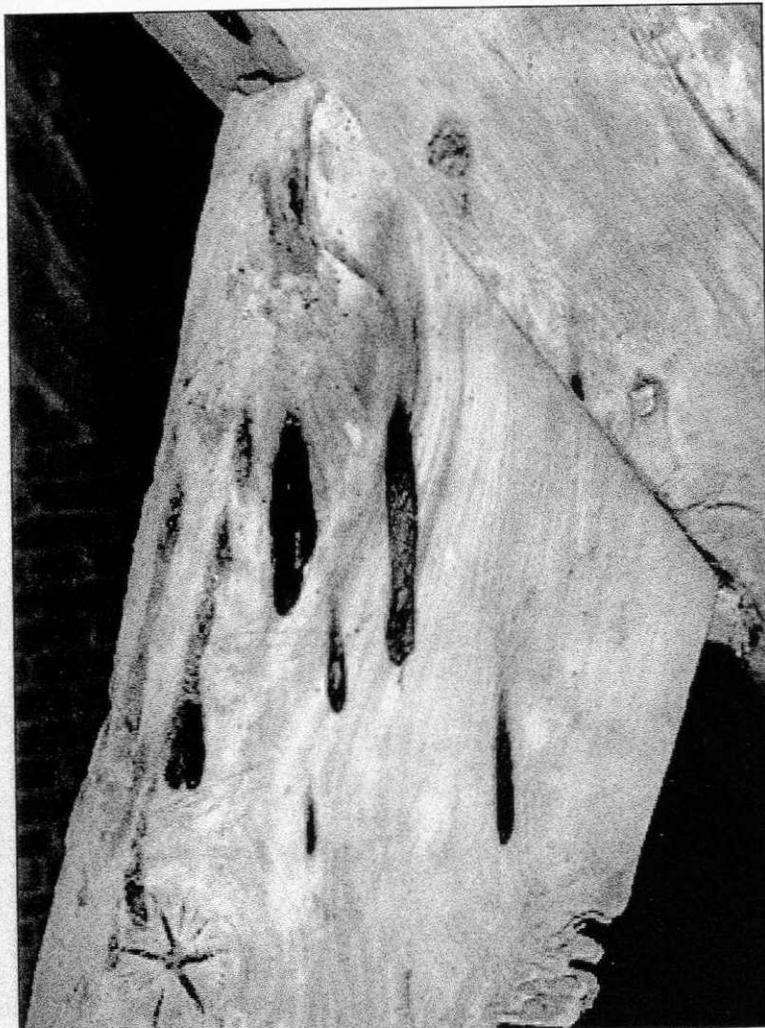
PLATE 92 (left): Taper burns on service wing roof trusses reveal attics were inhabited by servants

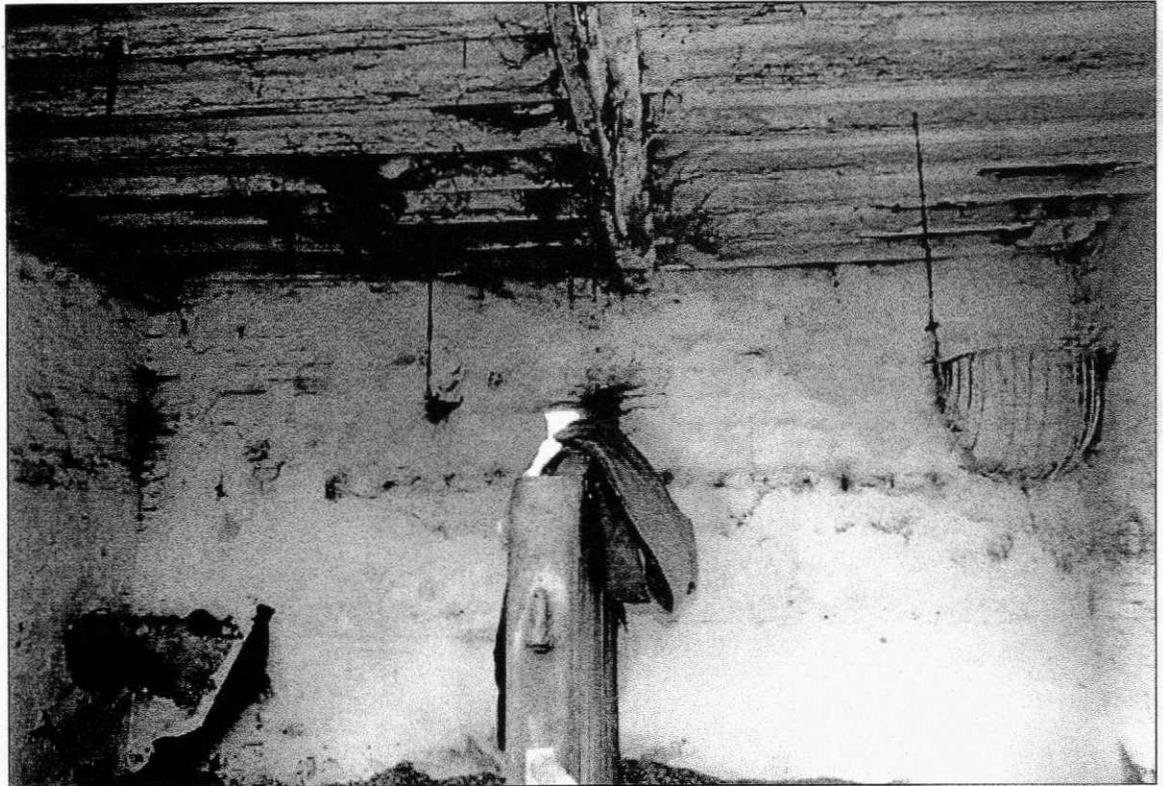
PLATE 98 (left): roof trusses of stable, 19th century

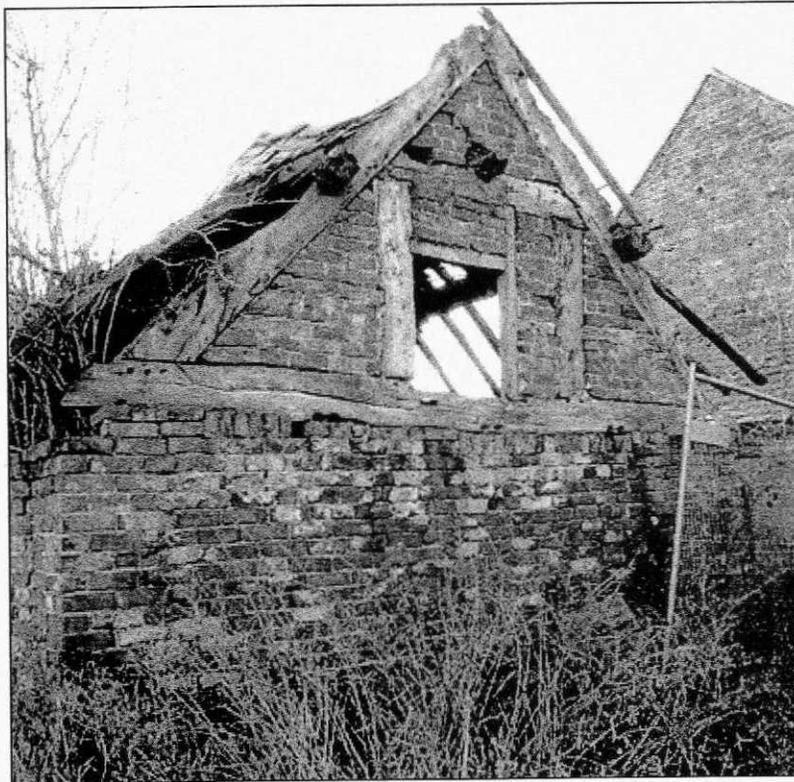
PLATE 100 (left): Timber-framed building of early 17th century that was probably an earlier stable

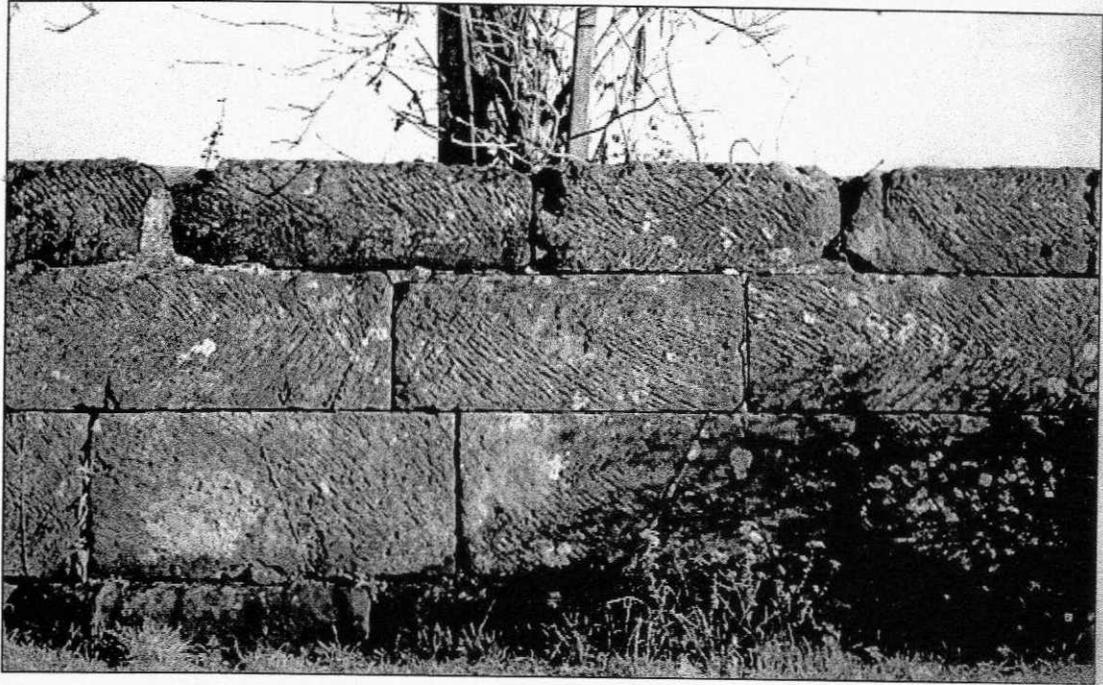
PLATE 106 (above): Section of tooled red sandstone wall on eastern side of farmyard
